SEE and TID of Emerging Non-Volatile Memories

D.N.Nguyen and L.S. Scheick

Jet Propulsion Laboratory
California Institute of Technology
Pasadena, California

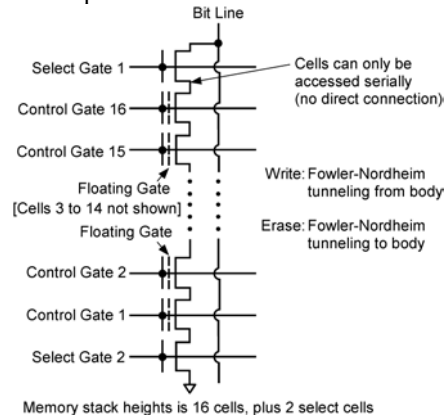
Figure 2: the NAND flash memory architecture

The NAND cell structure is shown in Figure 2 and in the NAND flash memory array, the bit line logic goes to “0” if all of the memory cell transistors are “ON”. Both architectures require charge pump circuits in order to provide

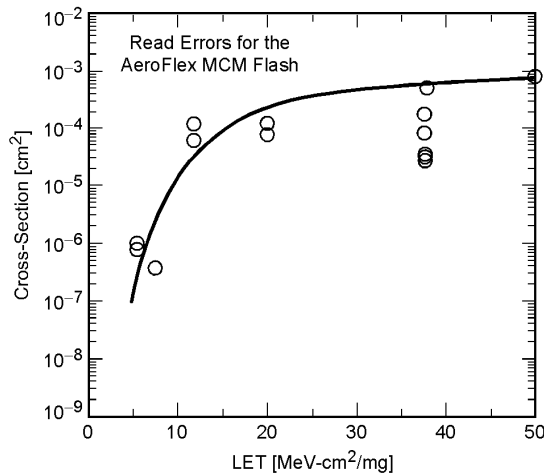
Figure 4: Cross-section of the dynamic read upsets (AeroFlex MCM)

Three AeroFlex MCM parts were tested with negligible variation among them. Figures 4, 5, and 6 are statistically fit using a model by Edmonds [3]. Three operational modes were tested during irradiation: read, write and erase. Static read (post-irradiation) test is also conducted. Figure 4 shows the test results of the dynamic read errors. SEFI happens occasionally with the sudden increase of device supply current. Restarting the read function or cycling power reset SEFI errors. No hard errors or bit erasures were seen in 10^{11} particles per centimeter.

Test results for the read-upsets of the SanDisk devices were very similar to the test results observed during the read mode of the AeroFlex MCM components. However, SEFI post-read lockup never occurred for SanDisk parts. Figure 8 displays the SEE read upsets of SanDisk components. Based on Figure 4 and Figure 8, the cross-section of read-upsets of the SanDisk was qualitative similar to those of AeroFlex MCM parts.

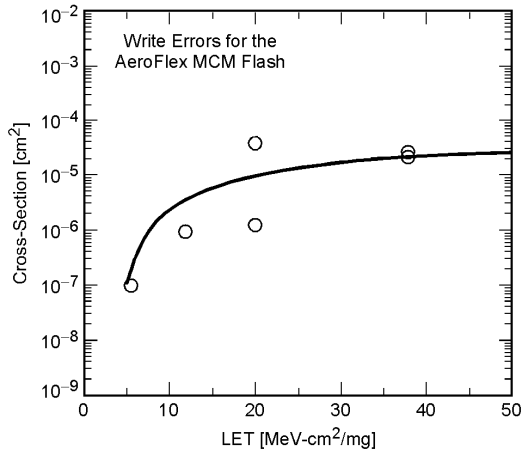
Figure 5: Cross-section of write-upsets (AeroFlex MCM)

Figure 5 illustrates test results of write errors. This occurs due to state machine being upset resulting in the changing of the address it was reading for validation from the address that was being written. Block-erase errors are similar to write errors since the erase operation is aborted before completion. Figure 6 shows the results of the test of the block-erase mode of all three DUTs.

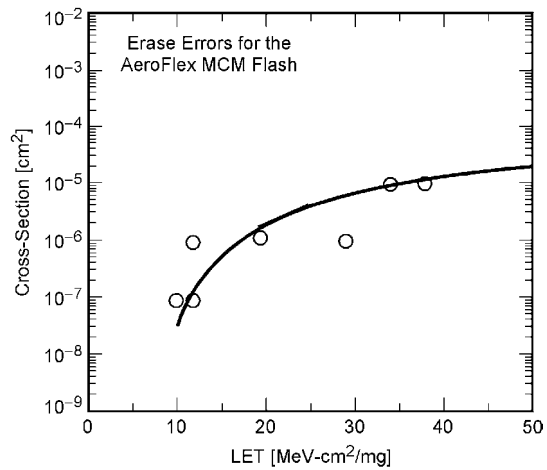
Figure 6: Cross-section of erase upsets (AeroFlex MCM)

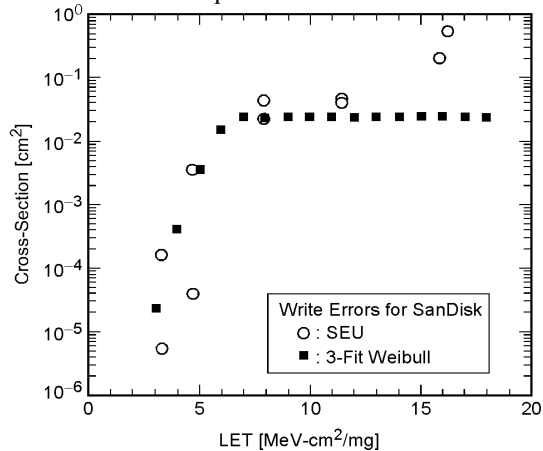
Figure 7: Cross-section of write-upsets (SanDisk)

One permanent bad block was observed after the lockup produced by a SEFI write upset. Figure 7 shows the cross-section of write upsets in SanDisk parts. Most SanDisk SEFI errors are write errors and similar to the AeroFlex SEFI lockups, they can be recovered with either power cycling or erase/write/read sequences.

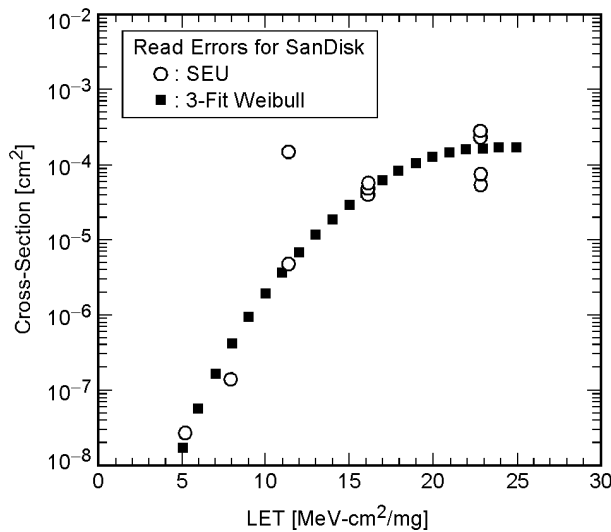
Figure 8: Cross-section of write upsets (SanDisk)

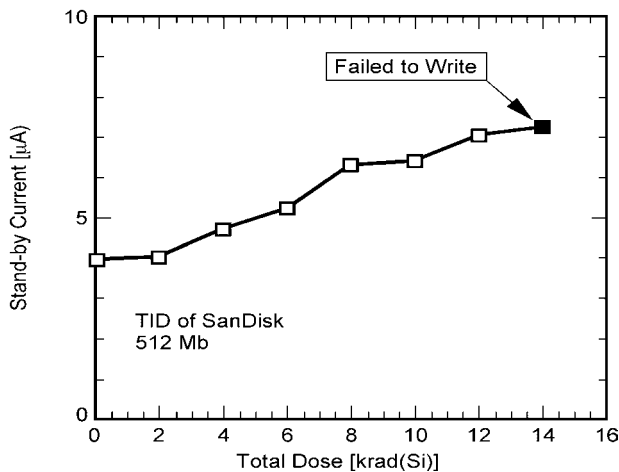
Figure 9: Total dose test results for the SanDisk 512Mb flash devices evaluated in full functional mode

The measured stand-by currents for SanDisk parts show no significant increase, a change of 3.26µA. The stand-by current of SanDisk devices went up to 7.22 µA at 14 krad(Si) at which functional failures occurred. Devices could be erased after 14 krad(Si). But the complement pattern could not be written to the DUTs and there were 5 million-bit read errors after 14 krad(Si). After 24 hours anneal at 3.3 volts and 25 degree C, one SanDisk part could be re-programmed. Previous generations of flash memory devices failed to erase at a lower level, around 8 krad(Si) with full functional tests including the erase/write/read sequence and could not recover after 24 hours annealing [4]. Figure 9 displays the TID response of SanDisk parts.

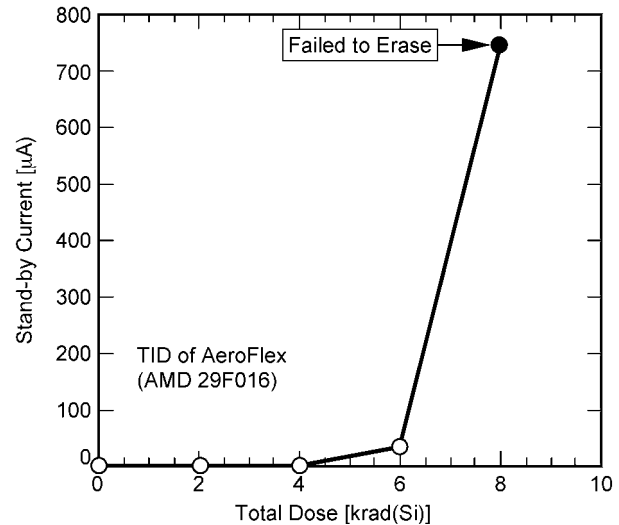
Figure 10: Total dose test results for AeroFlex MCM

The AeroFlex, two AMD29F016B parts, was evaluated in the similar setup as described in the previous paragraph. The AMD parts failed to erase after 8 krad(Si). The stand-by current went from less than 1 µA at the start of the test to 88 µA at 8 krad(Si). This implied that the oxide thickness of AeroFlex die is higher than those of the SanDisk devices. Figure 10 shows the total dose test results for the AeroFlex parts.
